Control of Wind Erosion

December 1971

State of California
Department of Public Works
Division of Highways
Materials and Research Department

CONTROL
OF
WIND EROSION

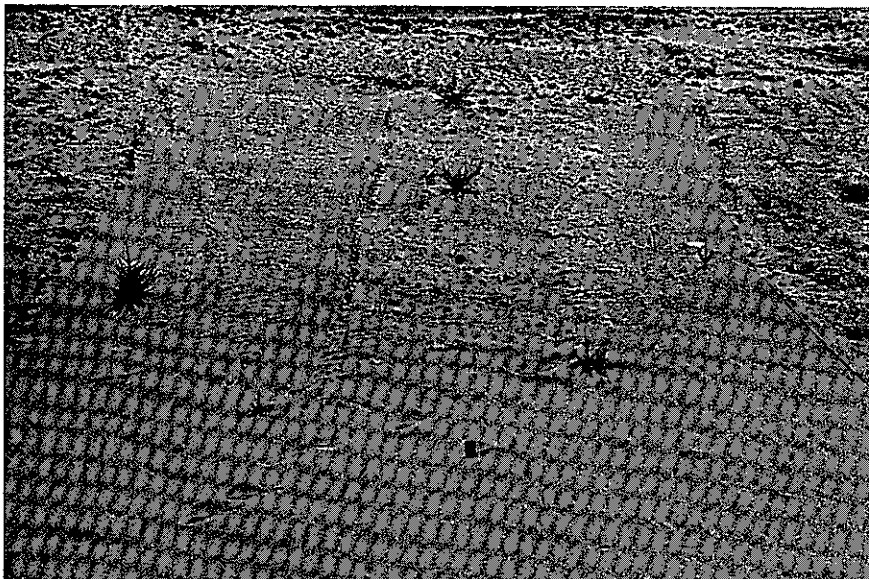
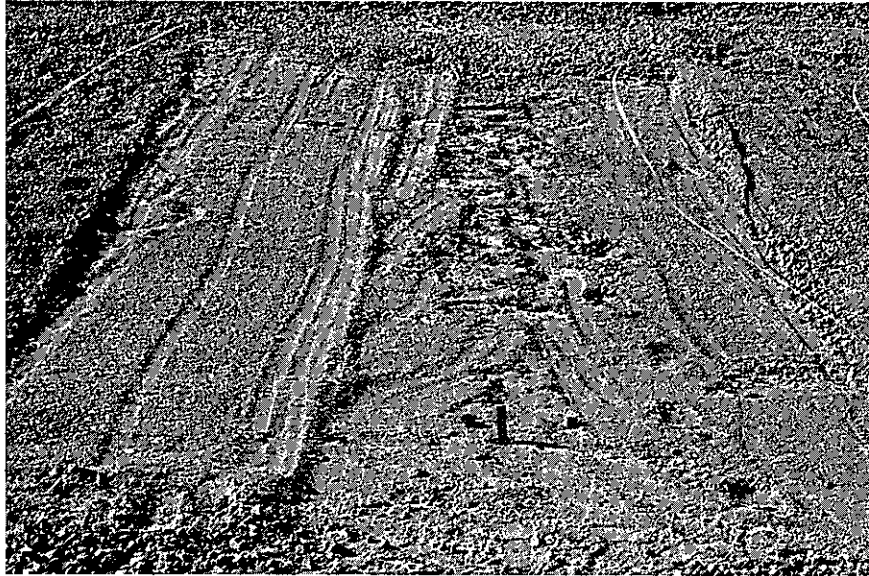
Plate 12 - Control Plot

The control plot, shown in Plate 12, was left untreated as a basis for comparison to the performance of the materials being tested. The surface of this control plot was sprinkled with water and a very weak crust did form. The blowing sand quickly destroyed this crust and most of the fine material on the test plot was subsequently blown away. As can be seen in Plate 12, a motorcycle was driven up the left side of this test plot.

Note motorcycle track

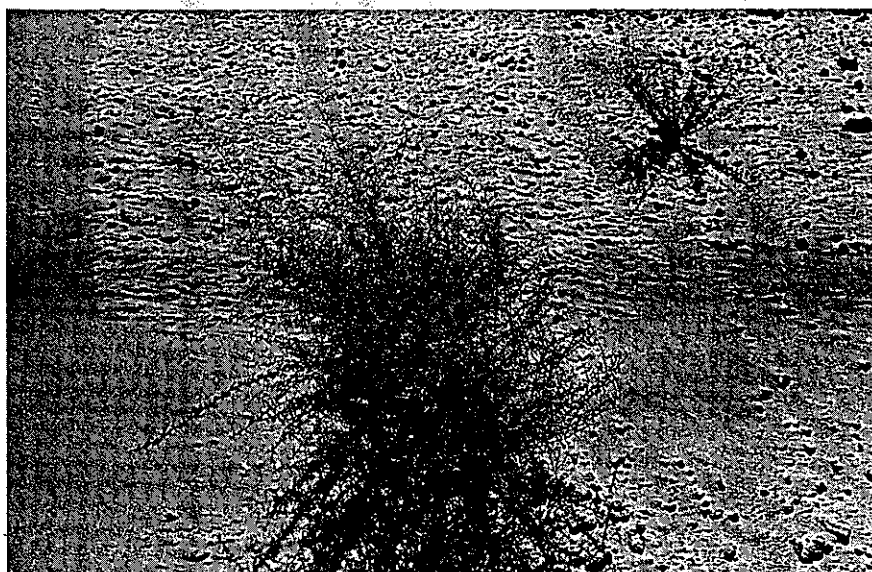
Plate 13 - Native vegetation on one of the test plots.

Although the test plots were not planted some native seed did germinate (See Plate 13). These plants grew primarily on the control plot and in the gravel blanket. Several plants grew on the Glenkote plot but probably germinated during the six-week interval between the other treatments and the Glenkote treatment. One plant sprouted on one of the test plots of both Aerospray 52 and Curasol AH. It appears that all treatments inhibit natural revegetation.

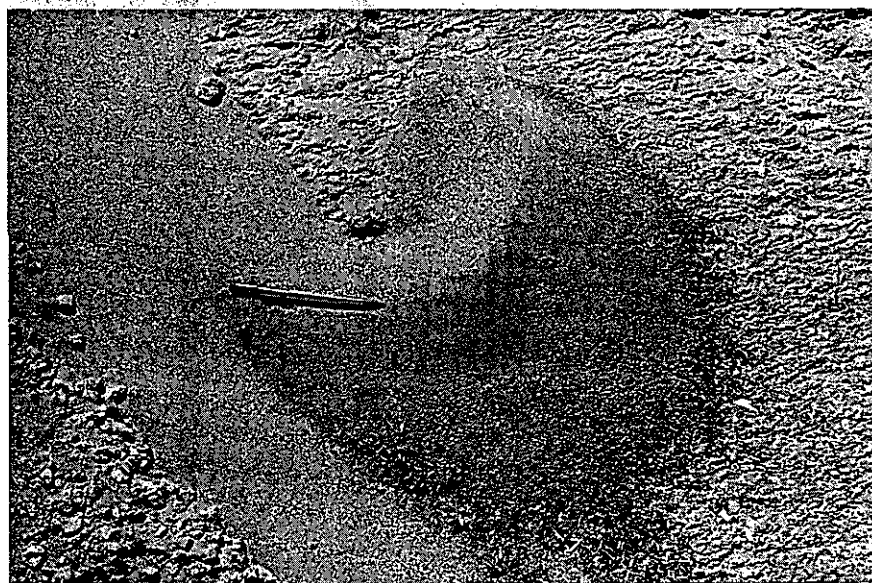
Plate 14 - Damage to test plot by burrowing insect.

Insects have excavated burrows (Plate 14) in nine of the test plots. These burrows appear to be independent of the treatment materials and have not affected the performance so they were not considered in making the evaluations.

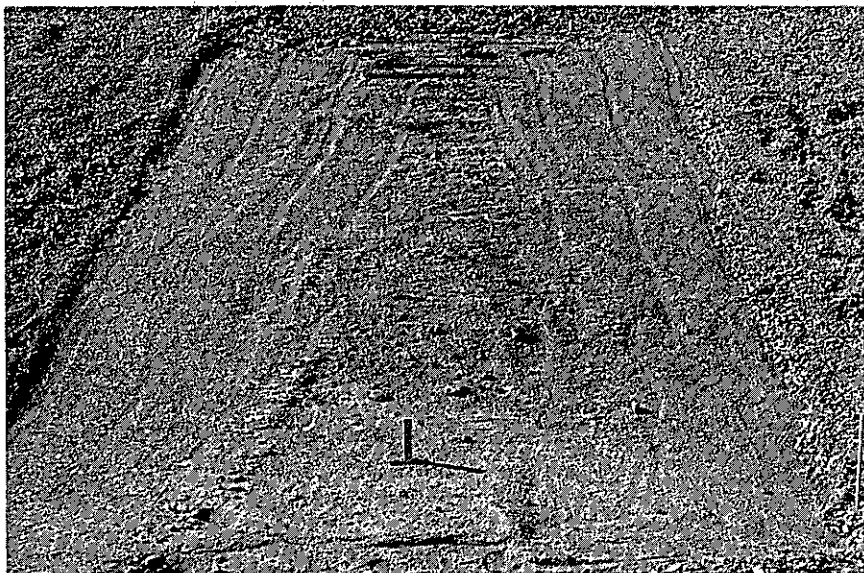
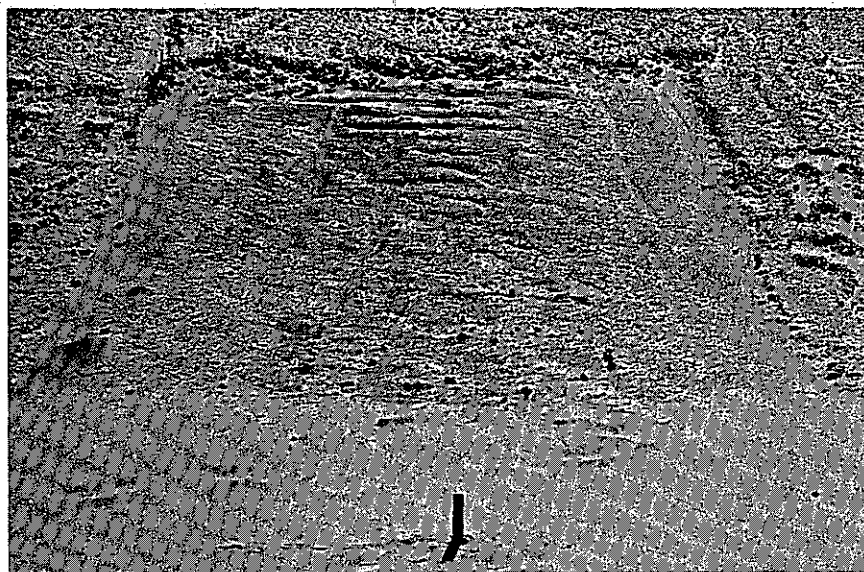
Aerospray is a white, viscous alkyd resin dispersed in water. It has no strong odor and was easy to handle and clean up. The test plots were premoistened before applying the diluted solution. After drying, Aerospray 52 left a colorless, thin, hard crust. Plates 15 and 16 show the test plots treated with Aerospray 52.

The performance of Aerospray 52 was judged marginal because the blowing sand had severely scoured the surface of the test plots and had locally cut through the crust. It should be noted that one plant did grow in one of the Aerospray test plots. This agrees with previous observations and suggests that Aerospray 52 may not be as severe in inhibiting germination as most other products tested in this study.

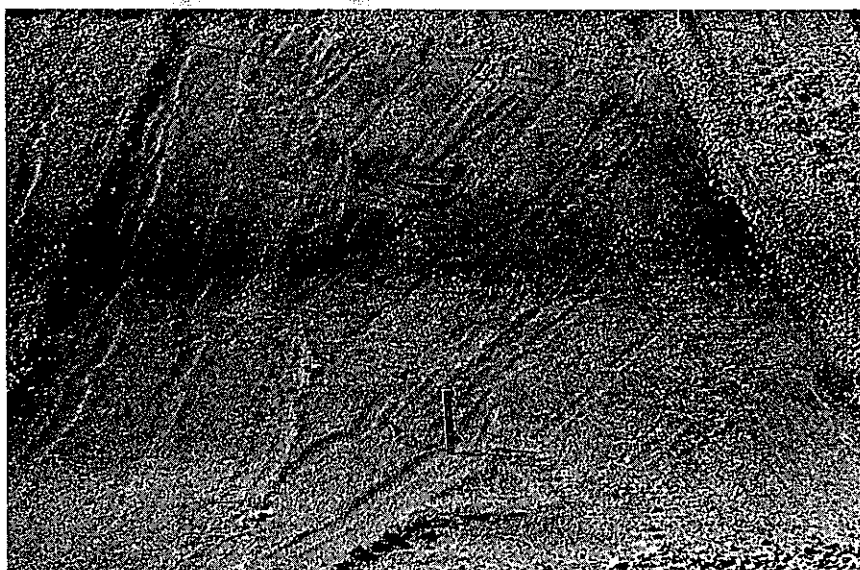
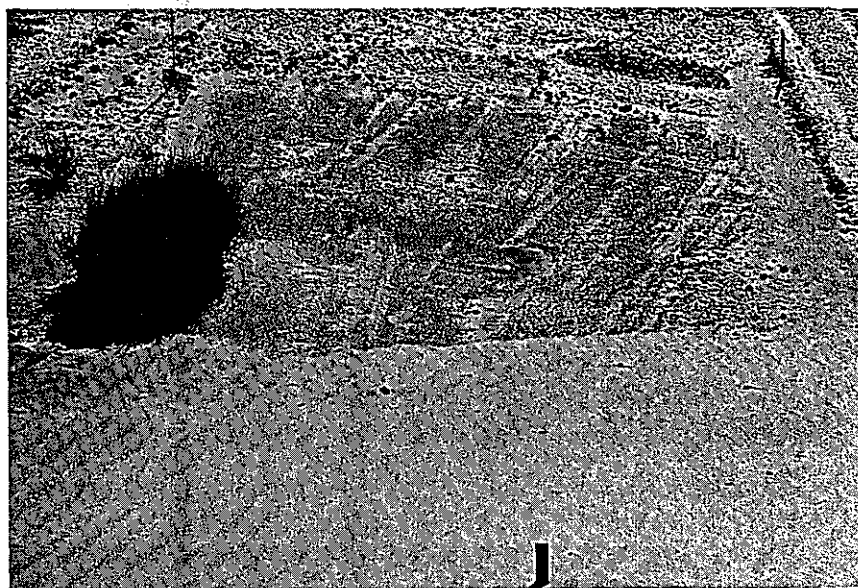
Plate 24 - Curasol AH

The comments on nature, appearance, use and difficulty of cleanup made in reference to Curasol AE all apply to Curasol AH. The difference between Curasol AH and all of the other plastic materials is that the surface formed is slightly thicker and is not hard and brittle. This surface flexibility appears to be desirable on soft surfaces such as uncompacted embankment slopes. Plate 24 shows the appearance of the test plot treated with Curasol AH.

The performance of Curasol AH was judged satisfactory because although scoured by blowing sand, the surface was not penetrated. One plant grew on the Curasol AH test plot at the southeast edge. This particular plant appears to have started in an accumulation of blow sand and the roots then penetrated the Curasol surface.

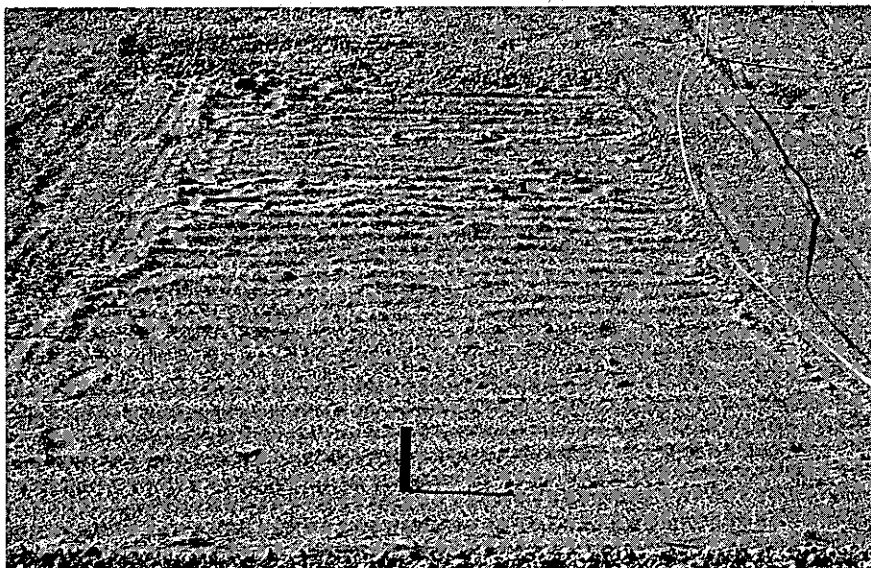
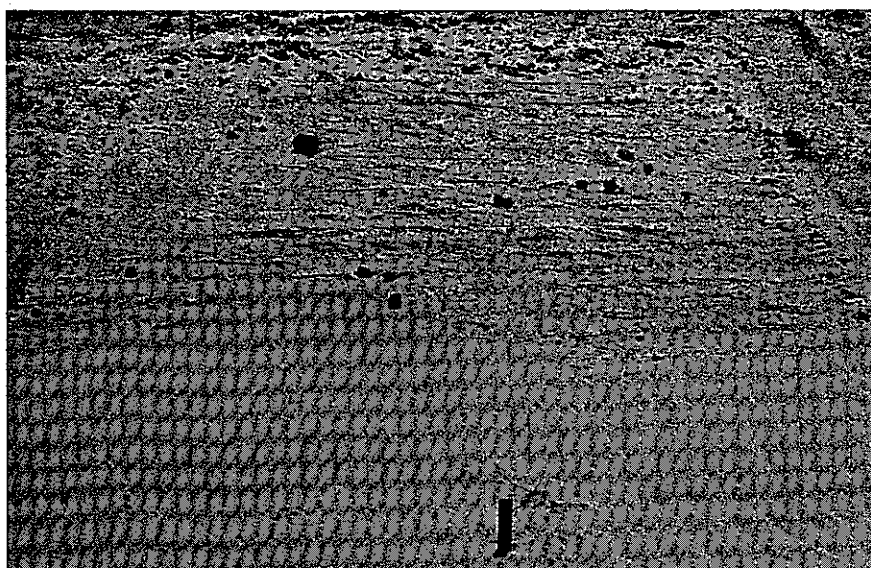
Plate 27 - Erode-X

Erode-X is a white viscous concentrate of an unknown plastic material which must be diluted with water before application. It has no strong odor and is easy to use and clean up. It dries to a colorless hard thin surface. Plates 27 and 28 show the test plots treated with Erode-X.

The performance of Erode-X was judged marginal because blowing sand had severely scoured the surface and had locally penetrated the surface.

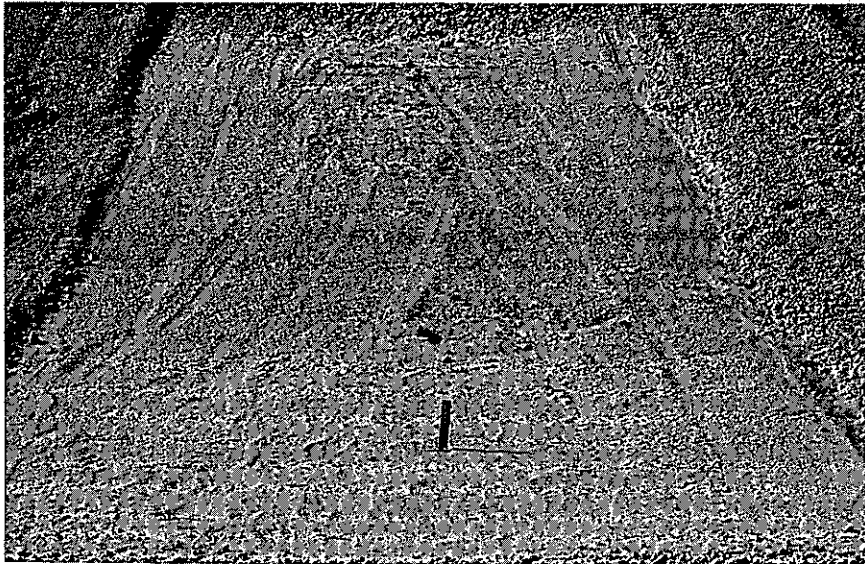
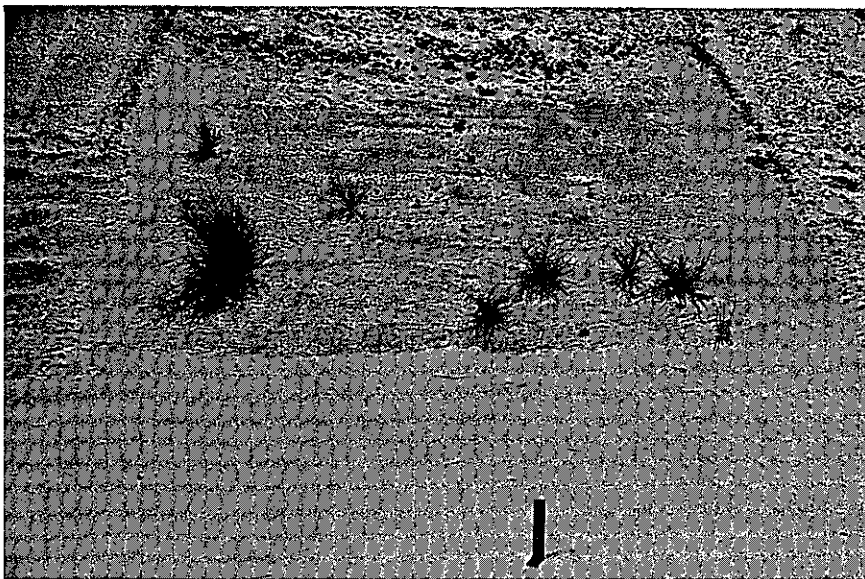
Plate 29 - Glenkote

Glenkote was developed for sealing rock roofs. It is a plastic material of unknown composition. It has no strong odor and is easy to use and clean up. It dried to a colorless thin hard surface. Plate 29 shows the test plot treated with Glenkote.

The performance of Glenkote was judged marginal because blowing sand had severely scoured the surface and locally had penetrated it.

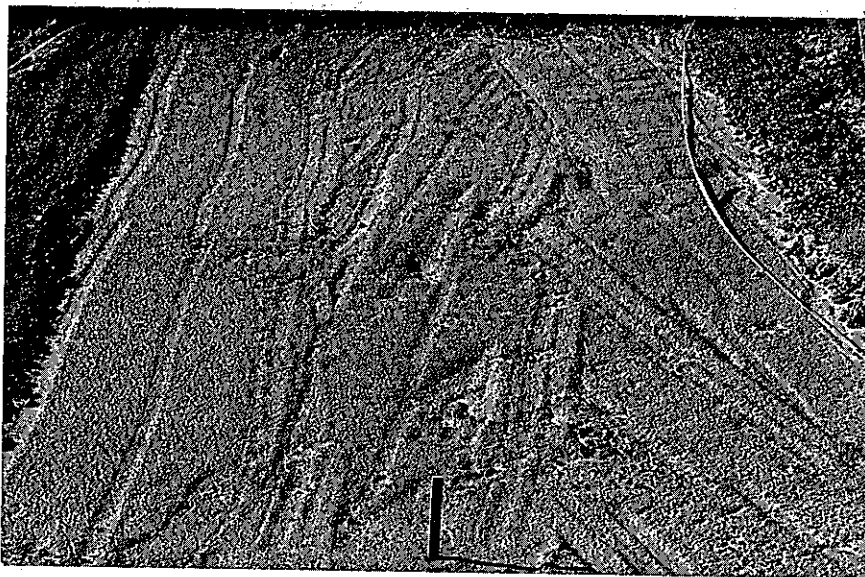
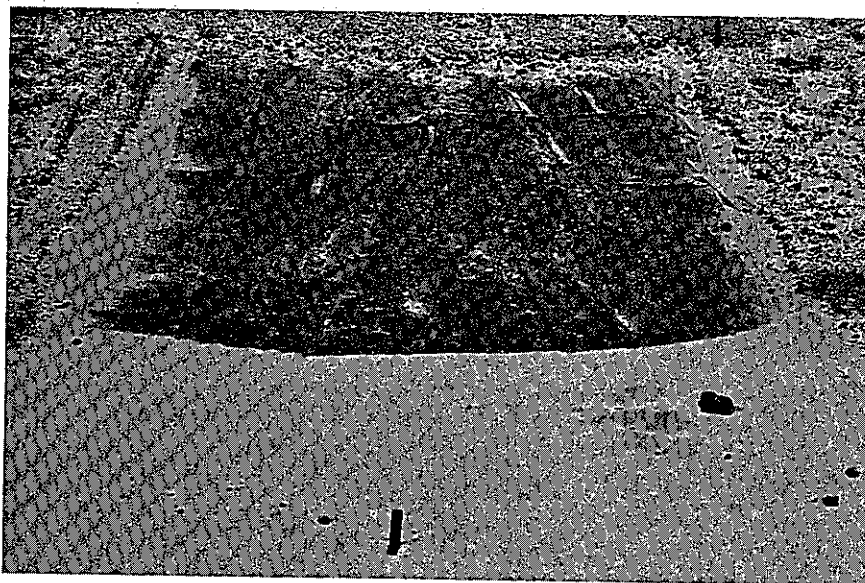
Plate 31 - Orzan

Orzan is a dark brown extremely viscous solution of chemicals and liquin sulfonate. It has a strong odor and is very easy to use and clean up. The dark color of this material did cause a discoloration of the test plot. Orzan exhibited remarkable penetration which resulted in a hard surface approximately three inches thick. This material also developed deep shrinkage cracks which did not interfere with performance but which are unsightly. Plates 30 and 31 show the test plots treated with Orzan.

The performance of Orzan was judged satisfactory because the surface was not damaged at all. The color and shrinkage cracks are definite disadvantages that should not be forgotten.

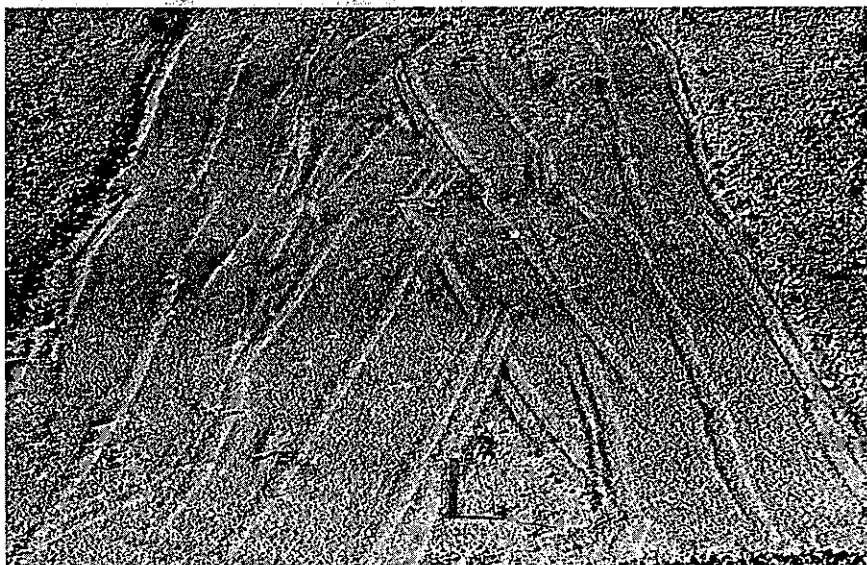
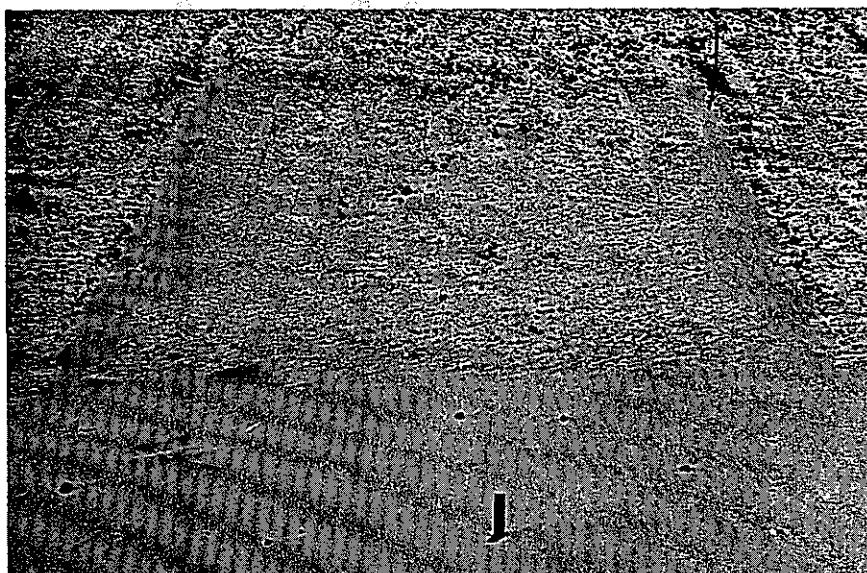
Plate 42 - Verdyol (Super)

Verdyol is a brown granular material that is not entirely water soluble and therefore requires agitation during application. The composition of this material is unknown, but it is organic and it has a slight odor similar to some kinds of fertilizer. Verdyol is easy to use and clean up. It dries to a colorless very thin hard surface. Plates 42 and 43 show the test plots treated with Verdyol.

The performance of Verdyol (Super) was judged unsatisfactory because the surface was completely destroyed and most fine material on the test plots has blown away.
